Project Info

CC CCT2® Bulk Rolls

G Sollentuna, Sweden

i To provide erosion control to a storm water drainage channel.

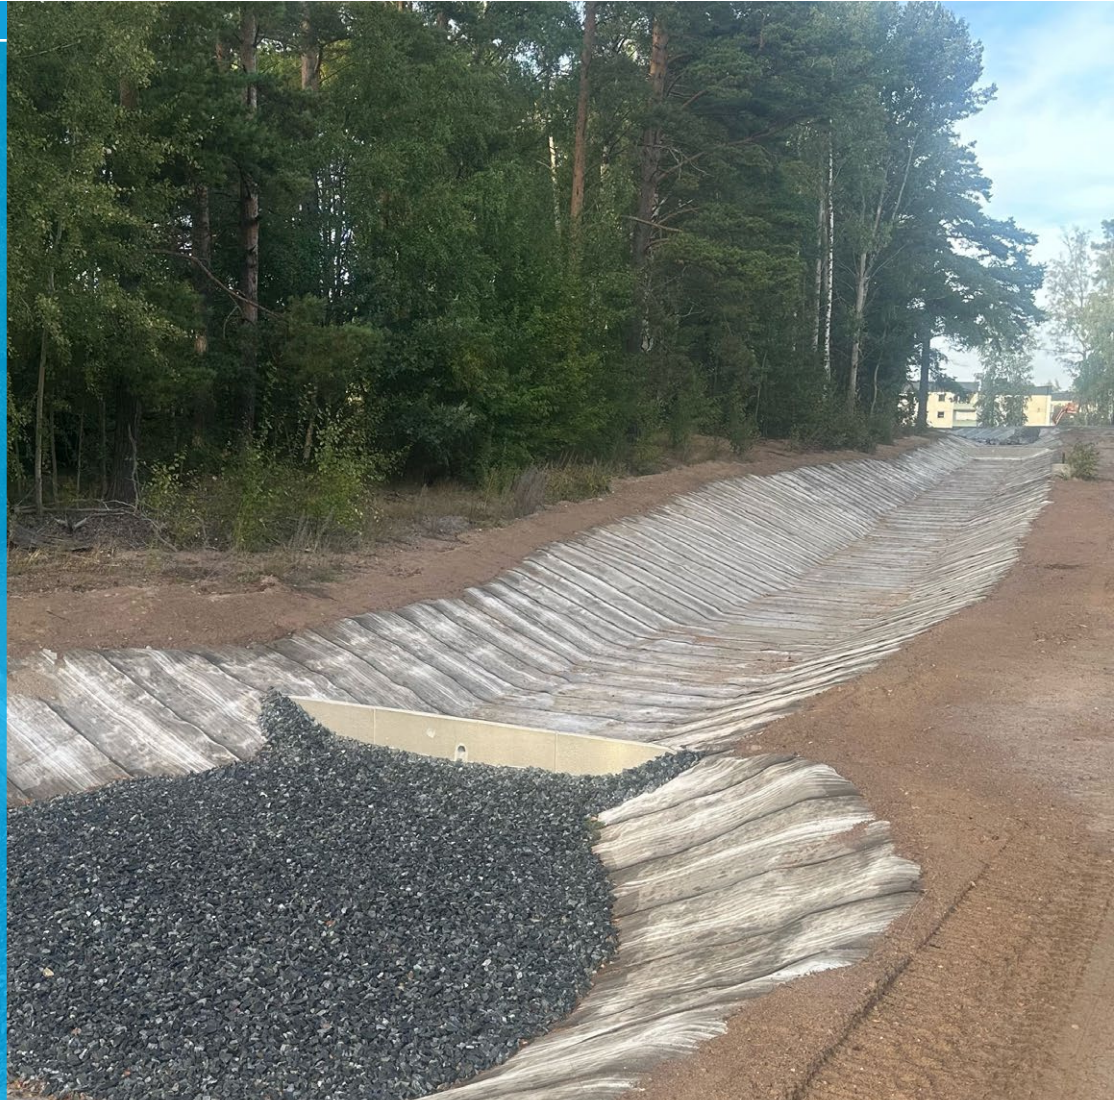
Completed Installation

In September 2024 Concrete Canvas® GCCM* (CC) was used to provide erosion control to a storm water drainage channel in Sollentuna, Sweden.

The drainage channel was designed to collect rain-water run off from the top of a slope and transport it down into the below drainage system. However, over time the unlined drainage channel was becoming increasingly damaged due to vegetation growth and erosion. To prevent further damage to the channel, clients SEOM VA-huvudman and Sollentuna municipaltit looked at a number of solutions.

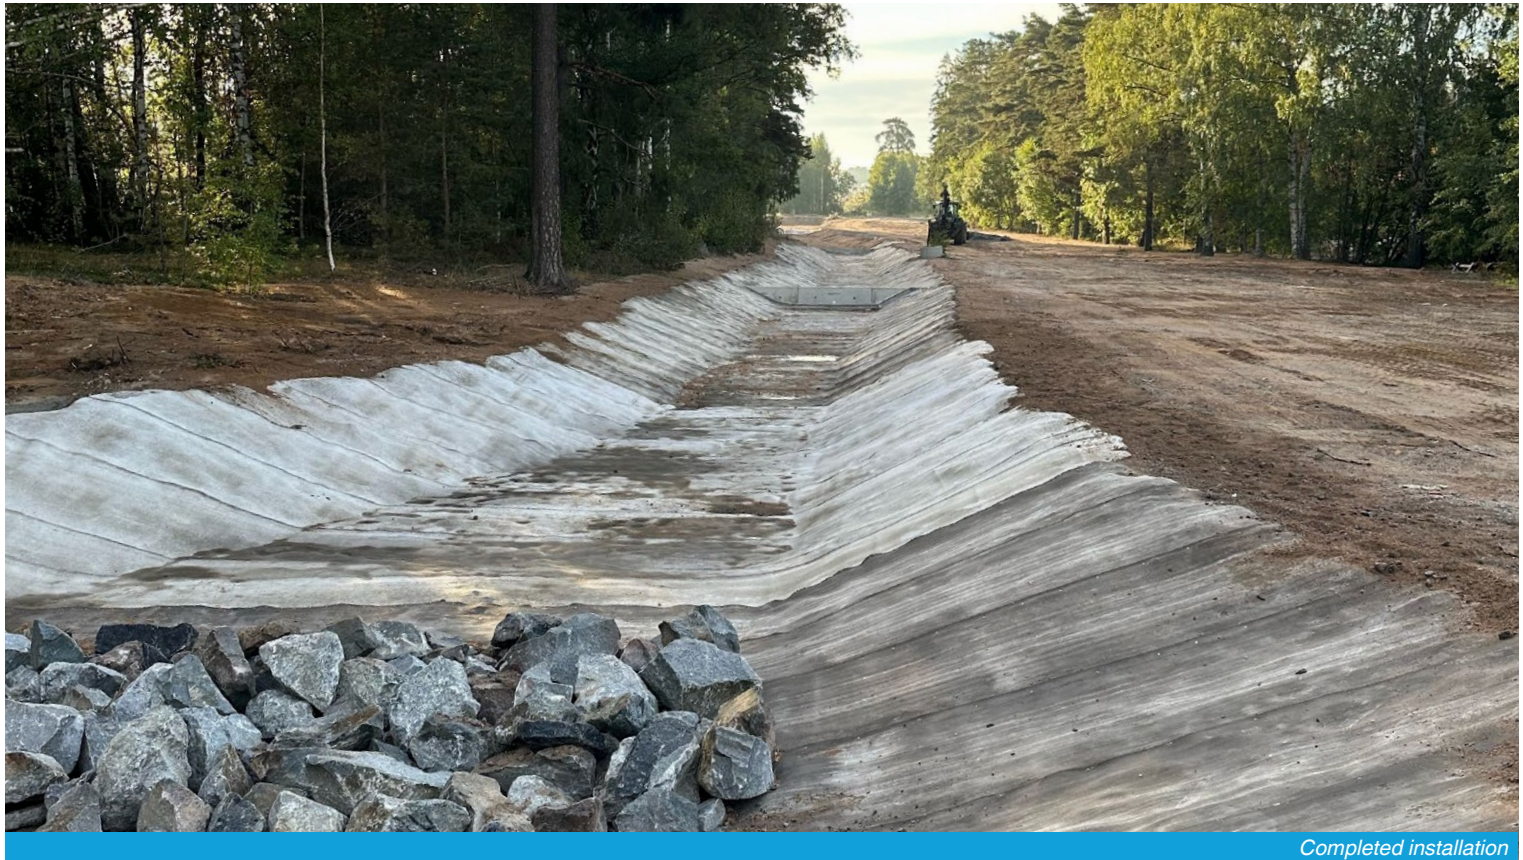
Completed installation

Prior to installation, the unlined drainage channel had to be re-profiled with the vegetation removed and the slopes within the channel graded into a uniform surface. Once the works were completed, Bulk Rolls of CCT2® were brought to site and lifted into place using an excavator with a spreader beam attachment. Each Bulk Roll was laid transversely across the channel and cut to desired length using a disc cutter. Each layer of CCT2® was overlapped by 100mm and joined using stainless steel screws spaced every 100mm in the direction of water flow. To prevent water-ingress and wind uplift, the CCT2® material was secured within pre-excavated anchor trenches using steel pegs placed through each overlap. Once the material was secured in place, it was hydrated using a water bowser and hose, with the anchor trenches then back filled with excavated substrate.

The installation was completed by a team of 2 from Häv och gräv i Östergötland AB in just 7 days. With 4 days spent excavating the drainage channel and 3 days to install and hydrate 1,500m² of CCT2®.
